ACTION MEMORANDUM

SUBJECT: Request for a Removal Action at the Sweet Kleen Laundry Site,
Buffalo, Erie County, New York

FROM: Kevin M. Matheis, On-Scene Coordinator
Removal Action Branch

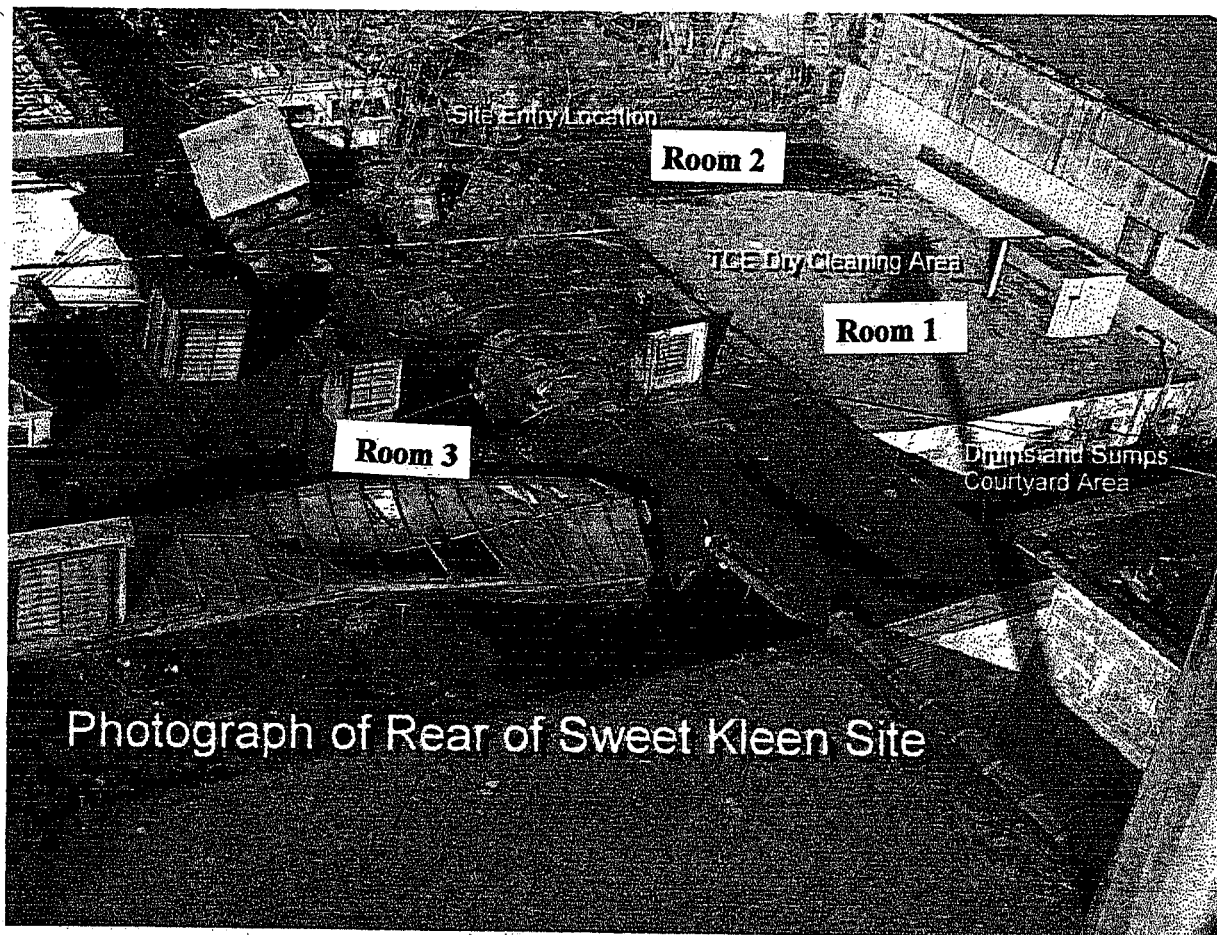
Attachment 5
Photo 2
Building Conditions

Several of the roofs in the Site buildings have collapsed. Other portions of roofs are in poor condition. Snow melt and rainfall contribute to the decay of the building structure and may have caused the roof to collapse, causing further deterioration to the asbestos and containers of hazardous substances.

Photograph of Rear of Sweet Kleen Site

- f. Demolition of Site buildings - The Site buildings are interconnected and are in a severe state of deterioration. The collapsed building sections have mixed with asbestos from pipe insulation and have created ACM debris. The ACM debris is situated in collapsed building sections and requires removal. This can only be accomplished by building demolition.

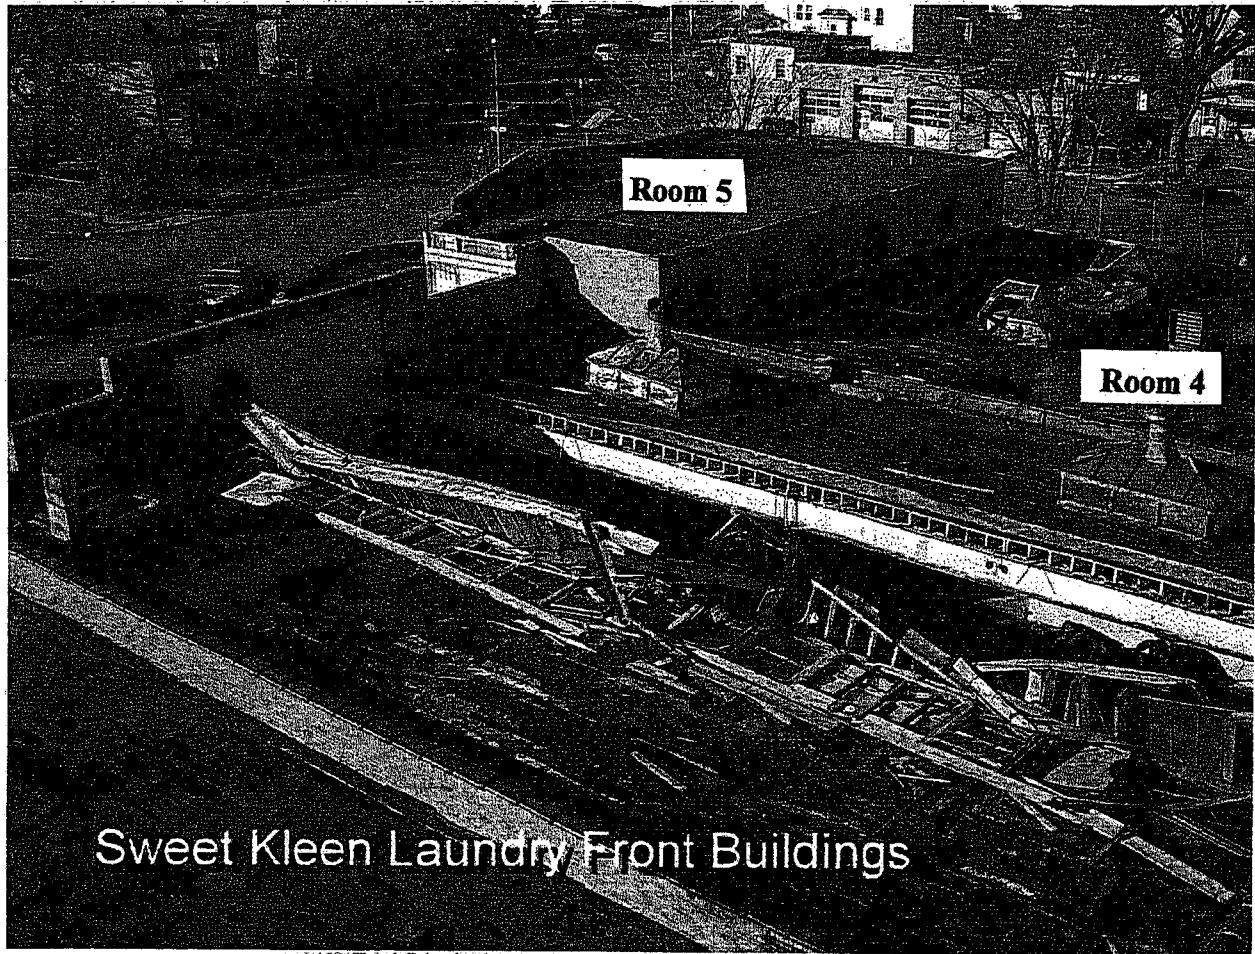
Attachment 5
Photo 3
Building Conditions

Sweet Kleen Laundry Front Buildings

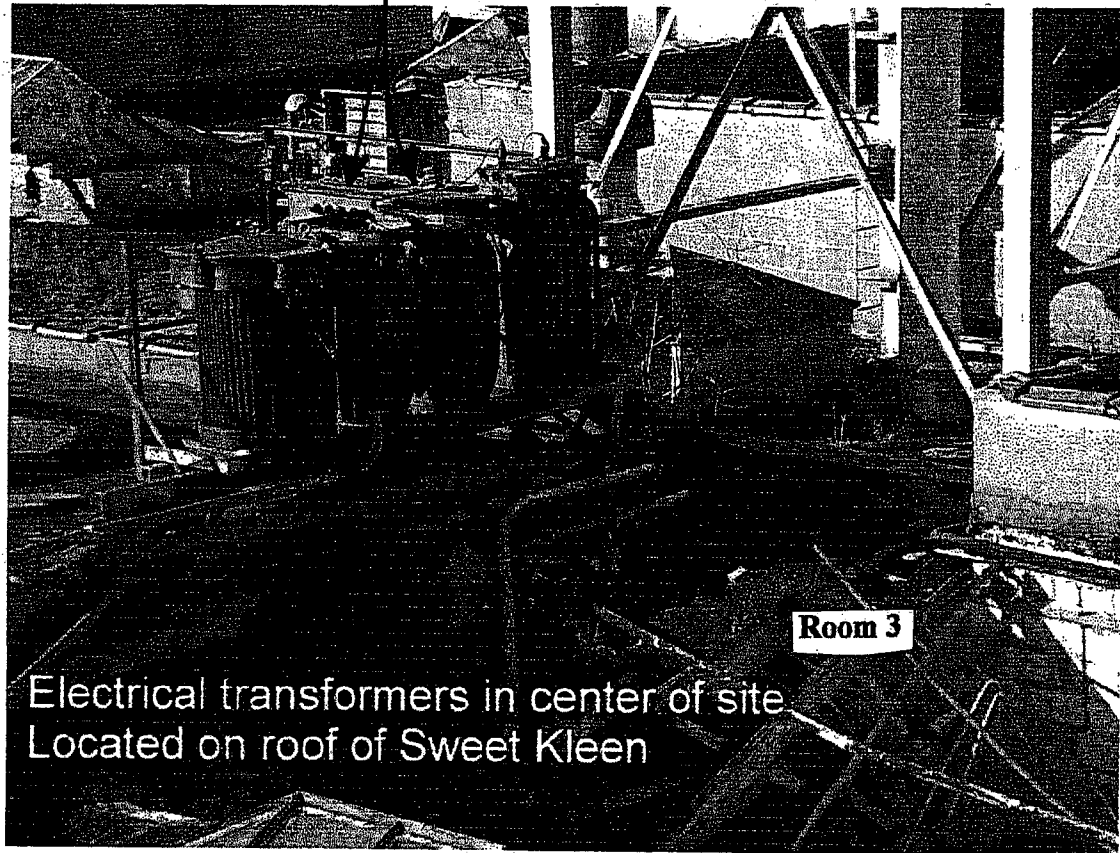
Attachment 5
Photo 4
Electrical Transformers

Four electrical transformers are situated on the roof above Room 3. The electrical transformers were inaccessible for sampling or label identification due to the poor condition of the roof and the collapsed portions of the Site buildings. Further building collapse may cause these transformers to release their contents. Aerial observations from a boom lift have shown that two of the four electrical transformers have had the lids removed in an apparent attempt to scavenge the metal from the transformers. It is unknown at this time if the transformer oil had spilled into the floor of Room 3. As part of this Action Memorandum, the transformers will be tested and removed from the Site. If they contain polychlorinated biphenyls (PCBs), soil sampling will be required in the area where the transformers were scavenged to determine if soil contamination exists.

Electrical transformers in center of site
Located on roof of Sweet Kleen
